DRAFT FINAL
Specific Site Assessment for
Coal Combustion Waste
Impoundments at Arizona
Electric Power Cooperative
(AEPCO) Apache Power Plant
Cochise, Arizona

Submitted to:
Lockheed-Martin Corporation
2890 Wood Bridge Avenue
Building 209 BAYF
Edison, NJ 08837

Submitted by:
GEI Consultants, Inc.
6950 South Potomac Street, Suite 300
Centennial, CO 80112

October 2009
Project 091330

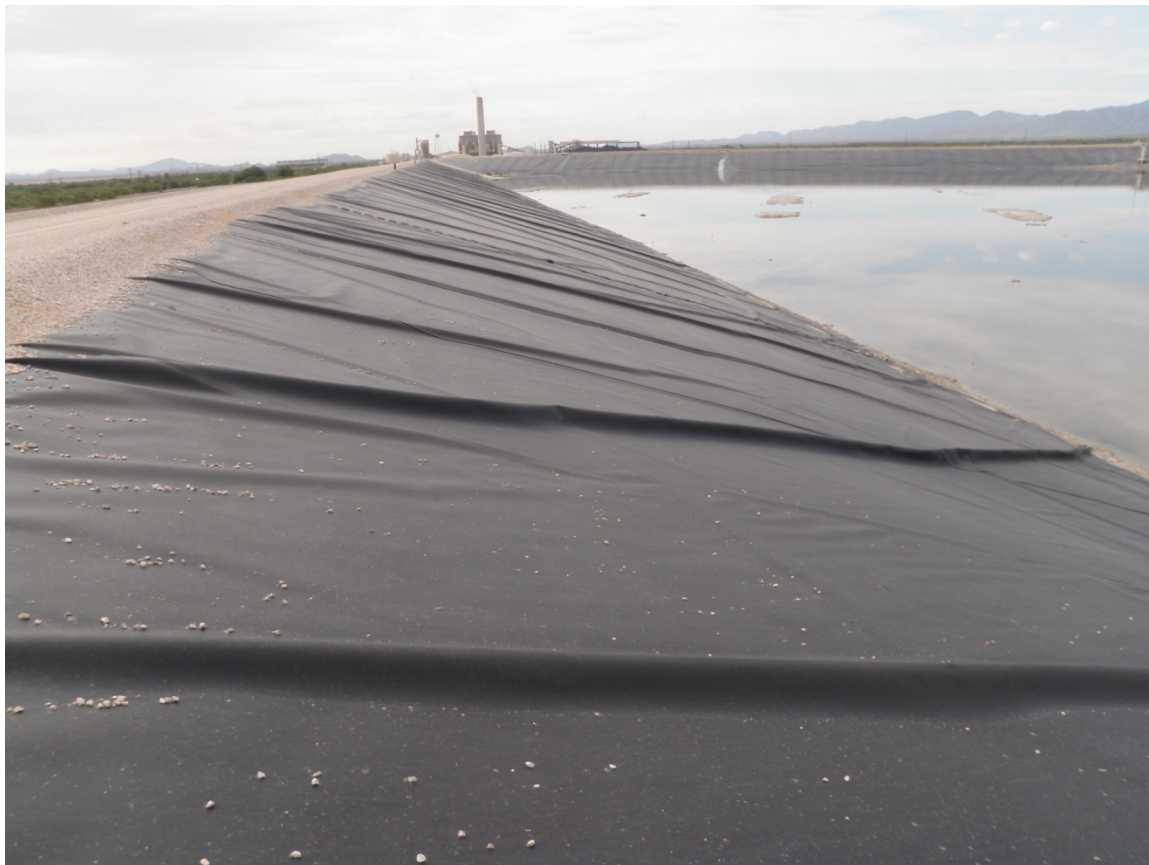
Photo 4: Crest of east embankment of Ash Pond 4 facing south.

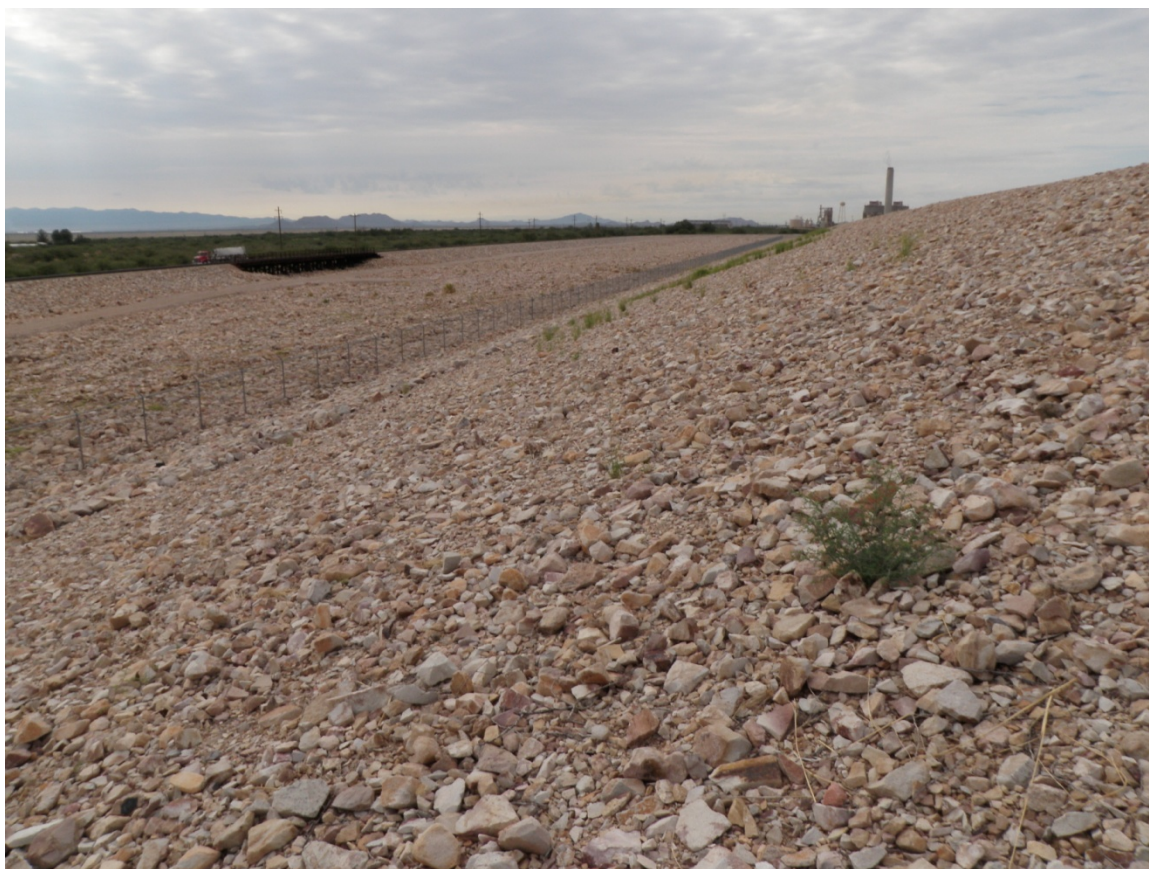
Photo 5: Upstream slope of east embankment of Ash Pond 4 facing south.

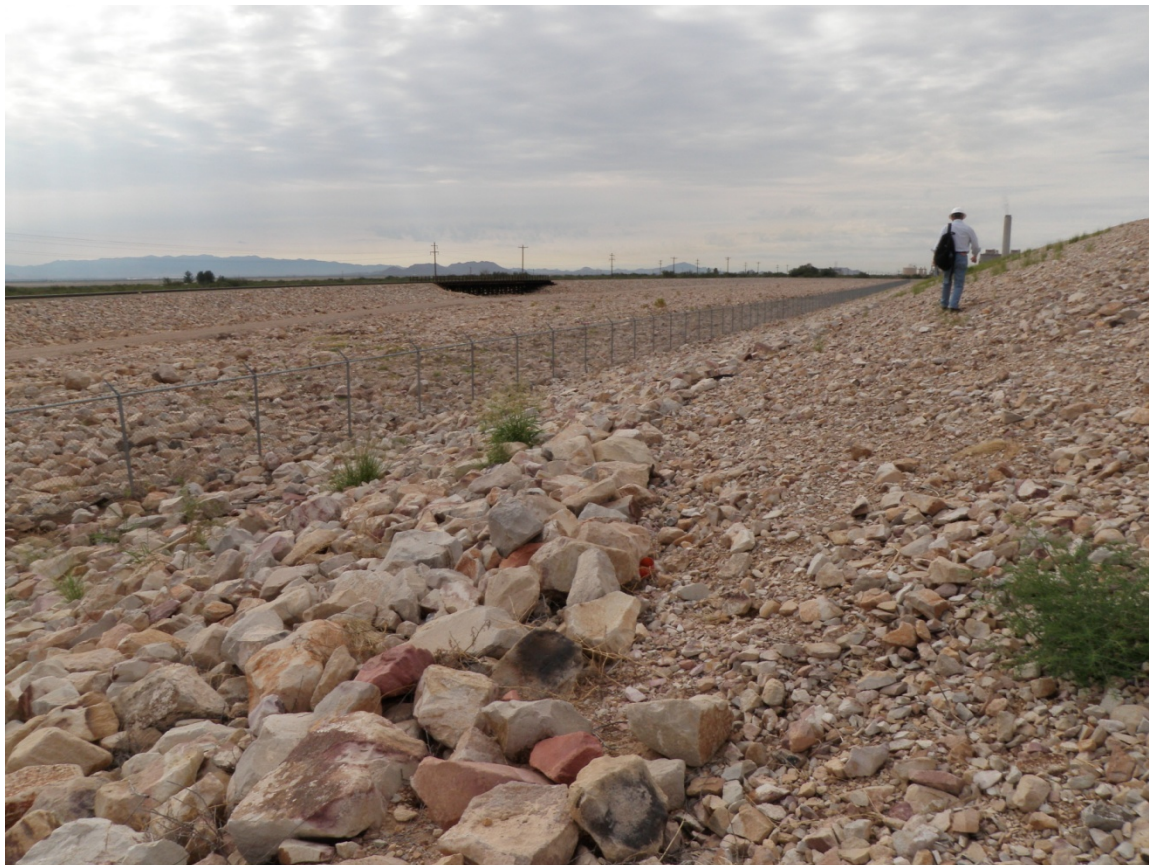
Photo 6: Downstream slope of east embankment of Ash Pond 4 facing south.

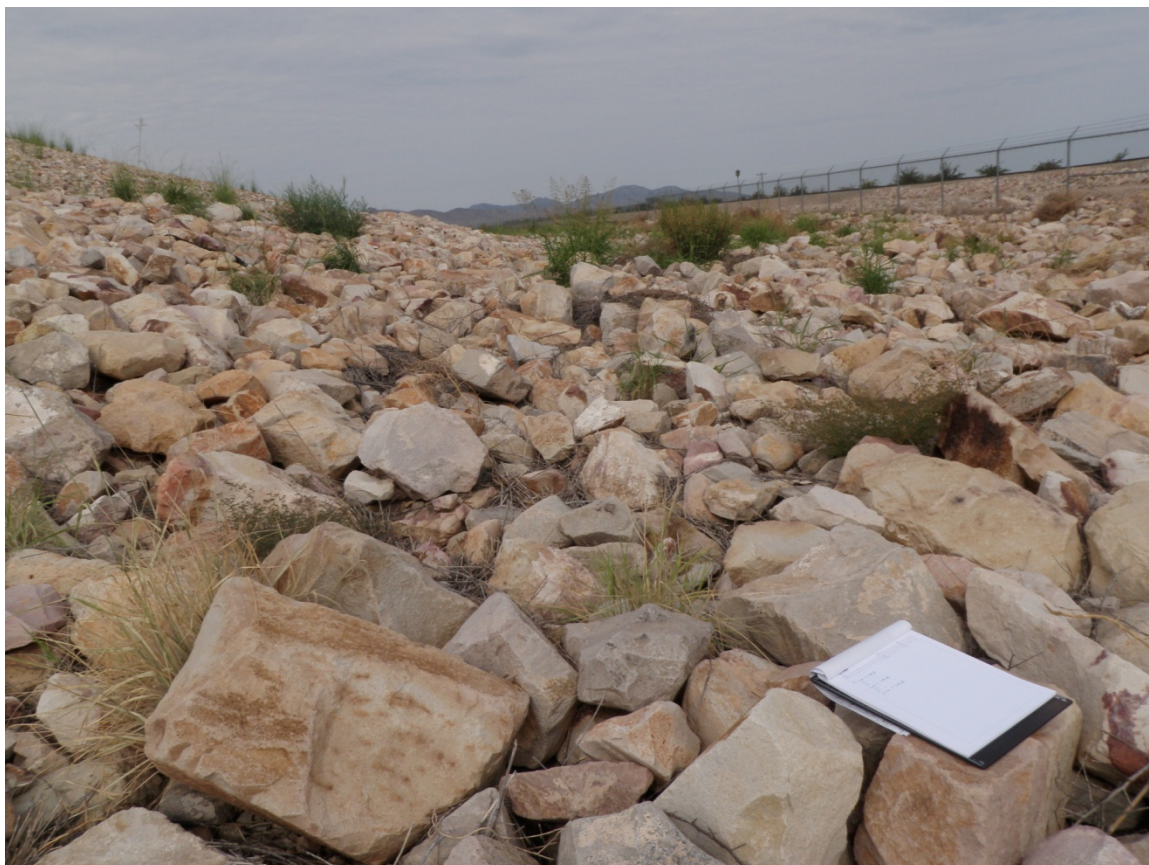
Photo 7: Downstream toe of east embankment of Ash Pond 4 facing south. Note granular rock slope protection and riprap in stormwater ditch at toe.

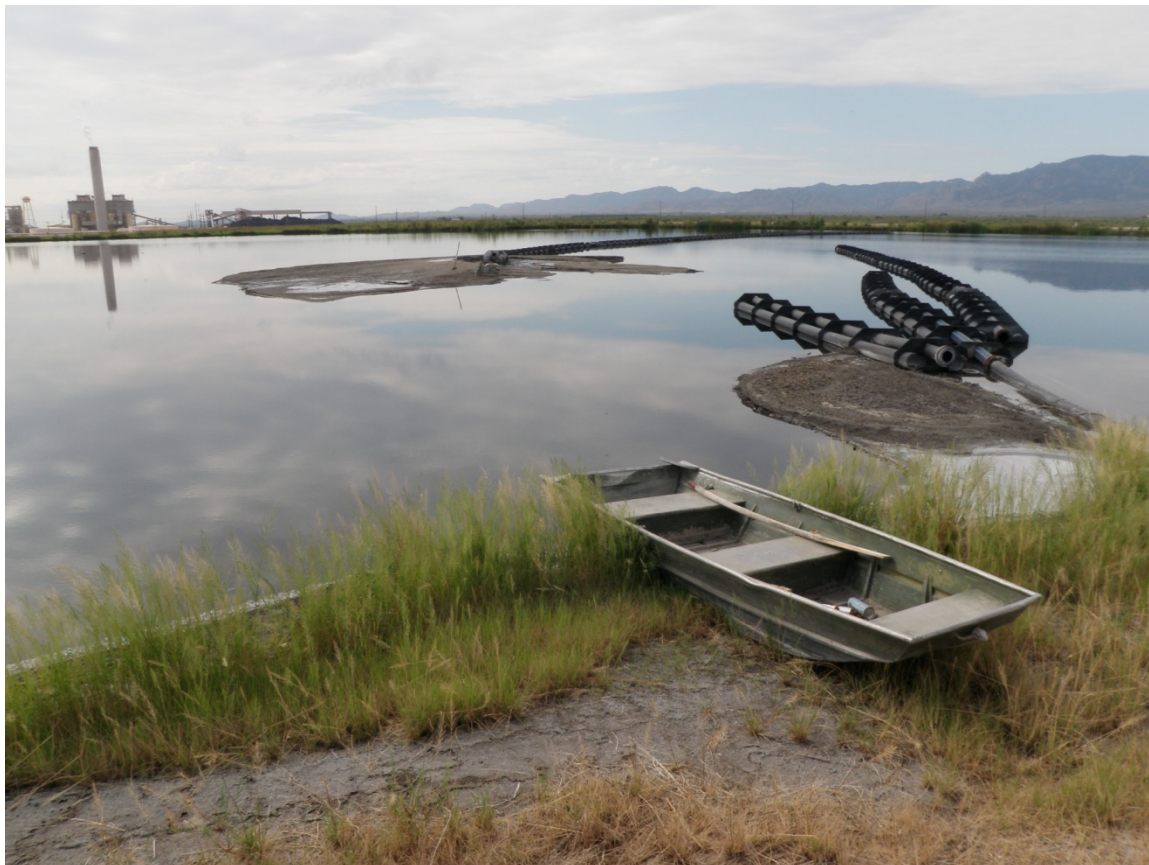
Photo 16: Looking downstream, east, at Pipe Vault
